Treatment of a Broken Central Incisor in Children After Trauma

by Khalil S. Saghezchi, D.D.S.

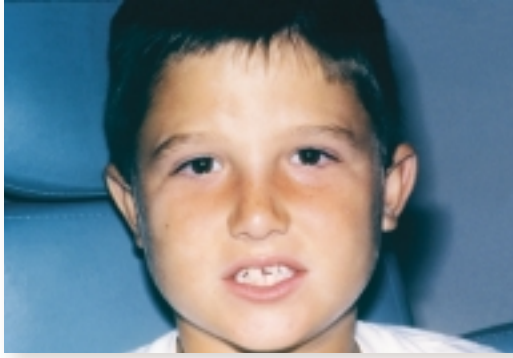
Figure 1: Preoperative picture.

The patient, a seven-and-a-half-year-old boy, had fallen on the floor and fractured the incisal one-third of tooth #9 (Fig 1). The child's father took him to the family dentist, who presented a treatment plan that the father felt was too aggressive (as a child, the father had had a negative dental experience resulting from the

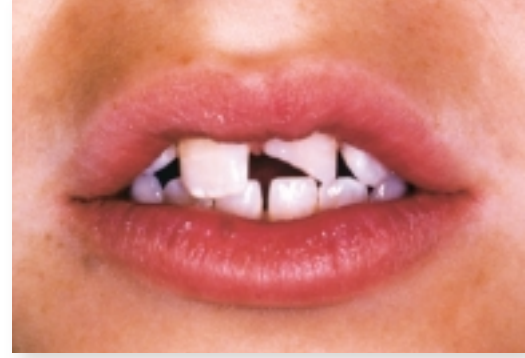
Figure 2: Preoperative smile, fractured #9.

same sort of trauma). Due to his son's young age, the father believed that a more conservative approach would be best. The father and child were referred to my office for a consultation. The father brought one x-ray and the fractured fragment of #9 in a plastic bag (Fig 2).

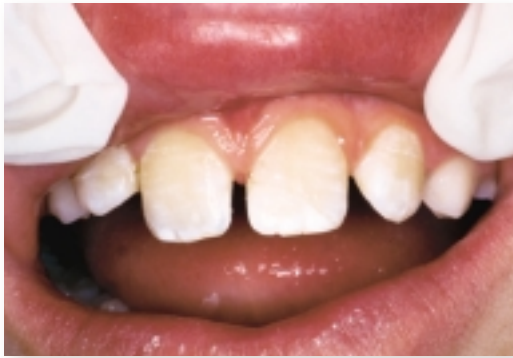
Figure 3: Verification of fractured fragment.

were limited to the most conservative, least invasive methods. The fractured fragment was evaluated, cleaned, and repositioned into place. Fit was verified and a putty stent with vinyl polysiloxane was fabricated to stabilize the fractured fragment during bonding time (Fig 3). After taking slides and photographs and considering the patient's age, the following treatment options were presented to the child's father:

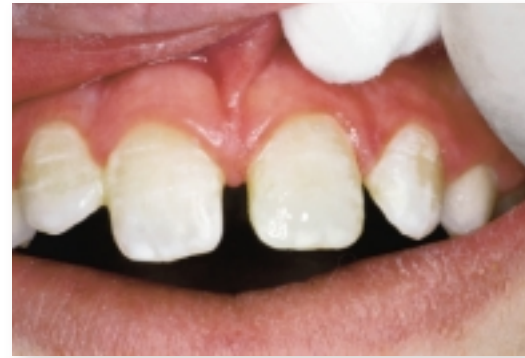
Figure 4: Bonded fractured fragment.

Effects of the trauma on the anterior teeth range from a simple crack to complete avulsion, depending upon the force and nature of the trauma.⁹ To increase the bonding strength and longevity of teeth restored by fragment reattachment in children, it is beneficial to overlap excess composite over the fracture line.¹⁰ In this case, as previously mentioned, due to a lack of occlusal contact between the upper and lower anterior teeth, a layer of hybrid composite was applied a couple of millimeters apical to the fracture line to the lingual incisal edge and light-cured. On the facial surface, a very thin layer of translucent composite was applied over the fractured line and light-cured (Fig 4).

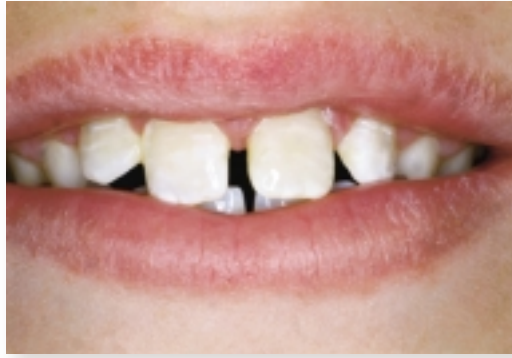
Figure 5: Finished case.

faces. Flexi Disks (Cosmedent) were used to polish the facial surface, followed with composite polishing paste. Football-shaped finishing diamonds (Brasseler; Savannah, GA) were used on the lingual surface to achieve lingual anatomy and followed with flexi finishing disks (Cosmedent), then followed with composite polishing paste. Occlusion was checked with different jaw movements to adjust any immature contact. The result was extremely satisfactory for the patient and his parents. The patient was recommended for a postoperative visit within a few weeks (Fig 5).

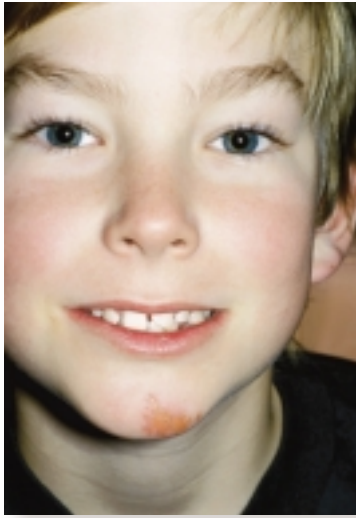
This 11-year-old boy came into the office with his mother to restore the fractured incisal one-third of tooth #9 (Fig 6). The etiology of this second case was a fall in the shower. Unlike the first case, the fractured fragment of this patient's tooth #9 had been lost. The patient's mother sought high-level, conservative restorative treatment to restore the fractured tooth to its natural appearance. Advances in modern composite formulation have provided clinicians with many different incisal and body shades to create an artistic restoration.

Figure 6: Case 2, preoperative view, fractured #9 with lost fractured fragment.

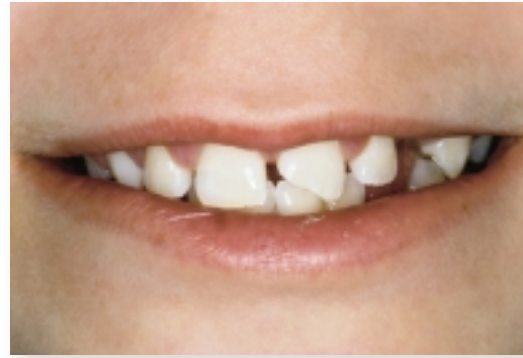
Figure 7: Case 2, preoperative smile, fractured #9.

Clinical exam revealed no signs or symptoms of temporomandibular joint or occlusal disorder. X-ray and clinical exam revealed no pulpal pathology. Teeth #8 and #9 had diastema with minimal restoration. Tooth #8 had no evidence of fracture (Fig 7).

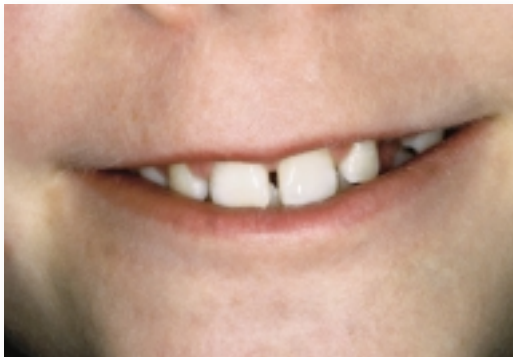
Figure 8: Repaired fractured tooth #9 with microfil composite.

The surface texture and the final form and function of restoration are achieved through careful finishing and polishing procedures. Disks, cusp, and points were used separately in this case. The final polishing was accomplished with composite polishing paste (Cosmedent). The final restoration (Fig 8) exhibited natural esthetic result (Fig 9).

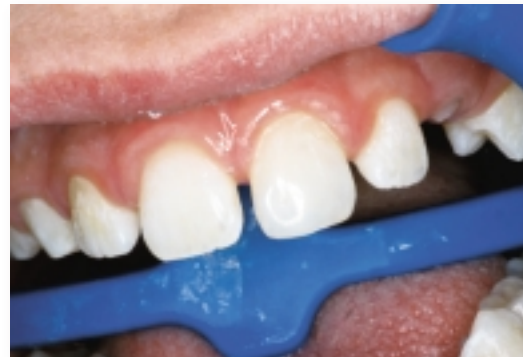
Figure 9: Retracted view of final repair.

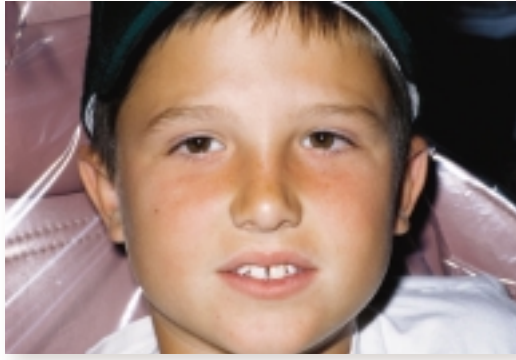
Figure 10: Postoperative portrait.

A fractured maxillary anterior tooth can be bonded with excellent results as long as the fractured fragment is not lost and is in one piece. In a short amount of time, the fragment can be disinfected and bonded together using dual-cure luting resin (Case #1). If the fractured fragment is lost, as long as significant amounts of tooth structure are not compromised, conservative restorative treatment such as that offered by the direct esthetic composite treatment outlined in Case #2 is generally an ideal choice for young patients (Figs 10 & 11). *AD*

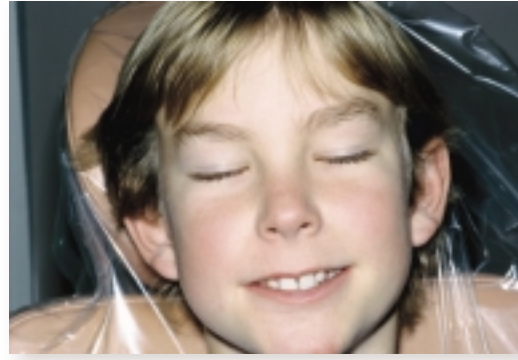
Figure 11: Postoperative portrait.
